# Resting among stars

The NASA Space shuttle must be the most sophisticated engineering accomplishment of humankind. The catastrophic loss of *Columbia* and crew at re-entry early this year was totally unexpected and a blow to manned space exploration. DIRK PONS looks into the final moments of *Columbia*.

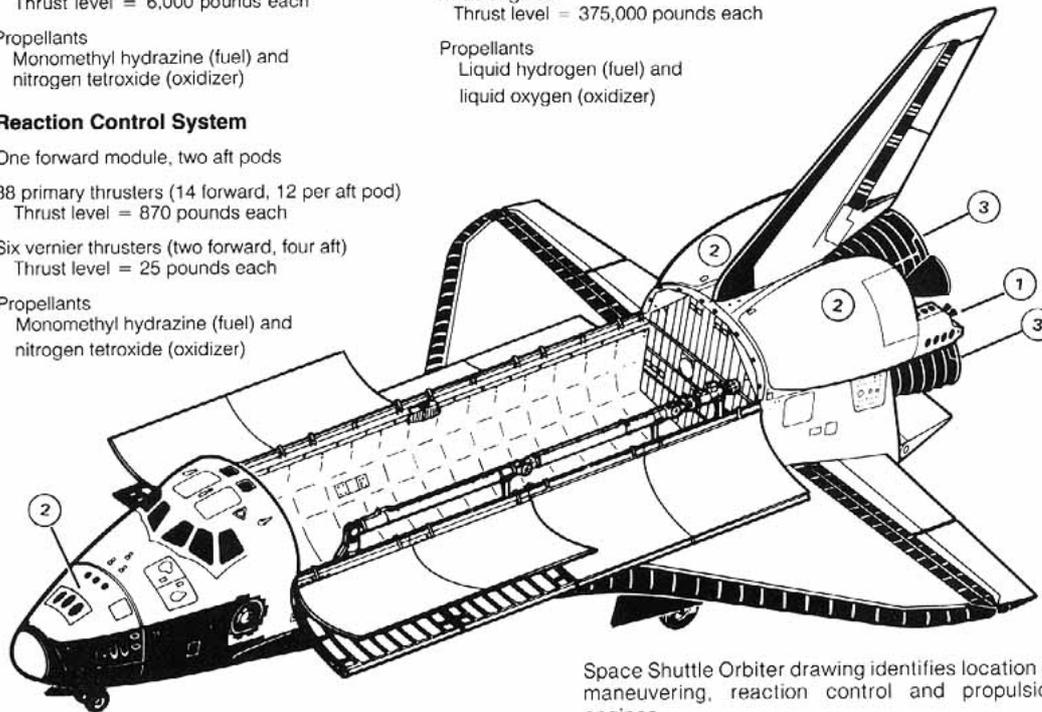
Space Shuttle Orbiter drawing identifies location of principal maneuvering, reaction control and propulsion system engines.

Figure 1: Diagram of Space Shuttle showing principal flight control engines. The rudder and ailerons are also visible, and are aerodynamically effective in the latter part of re-entry. Courtesy NASA (1986).
