GEOTECHNICAL ASPECTS OF THE 22 FEBRUARY 2011 CHRISTCHURCH EARTHQUAKE

SUMMARY

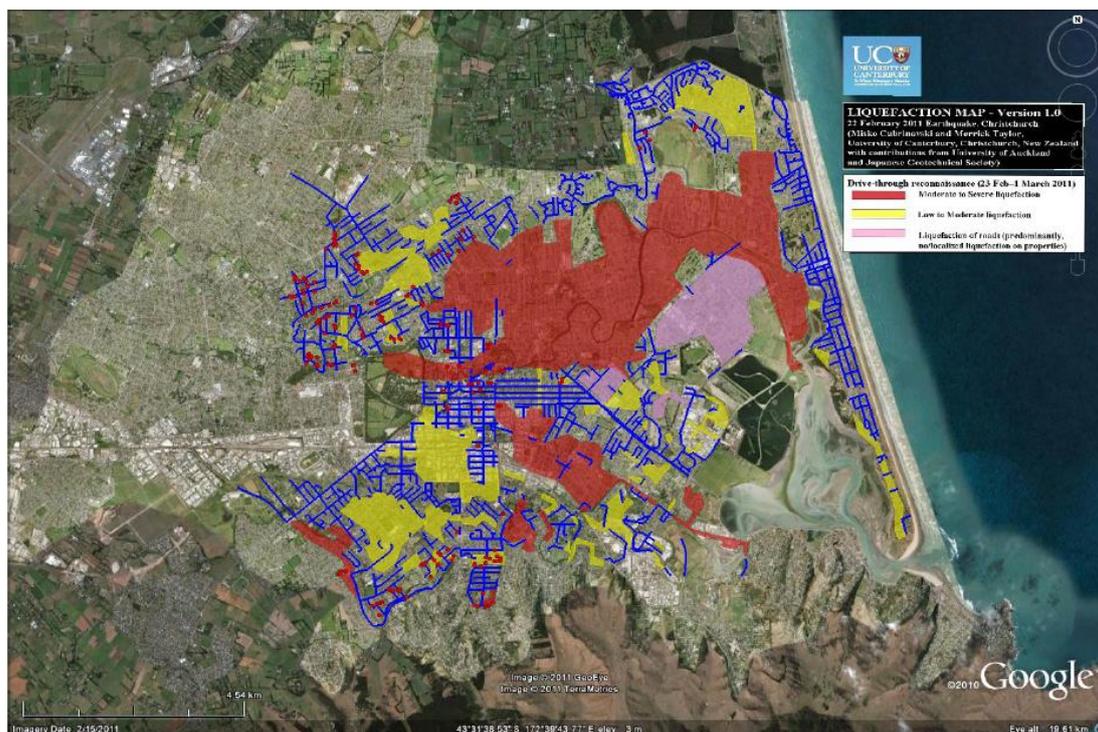
A distinctive feature of the 22 February 2011 earthquake, as well as other recent events which have produced strong ground shaking in Christchurch city, was the severity and spatial extent of liquefaction observed in native soils. Figure 4 shows the extent of liquefaction caused by the 22 February 2011 earthquake in the greater Christchurch region based on a drive-through reconnaissance [10]. Four areas of different liquefaction severity are indicated in the map: (a) moderate to severe liquefaction (red zone, with very large areas covered by sand ejecta, large cracks and fissures in the ground, and significant liquefaction-induced impacts on buildings), (b) low to moderate liquefaction (yellow zone, with generally similar features as for the severe liquefaction, but of lesser intensity and extent), (c) liquefaction predominantly on roads with some on properties (magenta zone), and (d) traces of liquefaction (red circular symbols, with clear signs of liquefaction, but limited in extent and deemed not too damaging for structures). Blue lines indicate areas where no

Figure 4: Preliminary liquefaction map of Christchurch from drive-through reconnaissance [10]

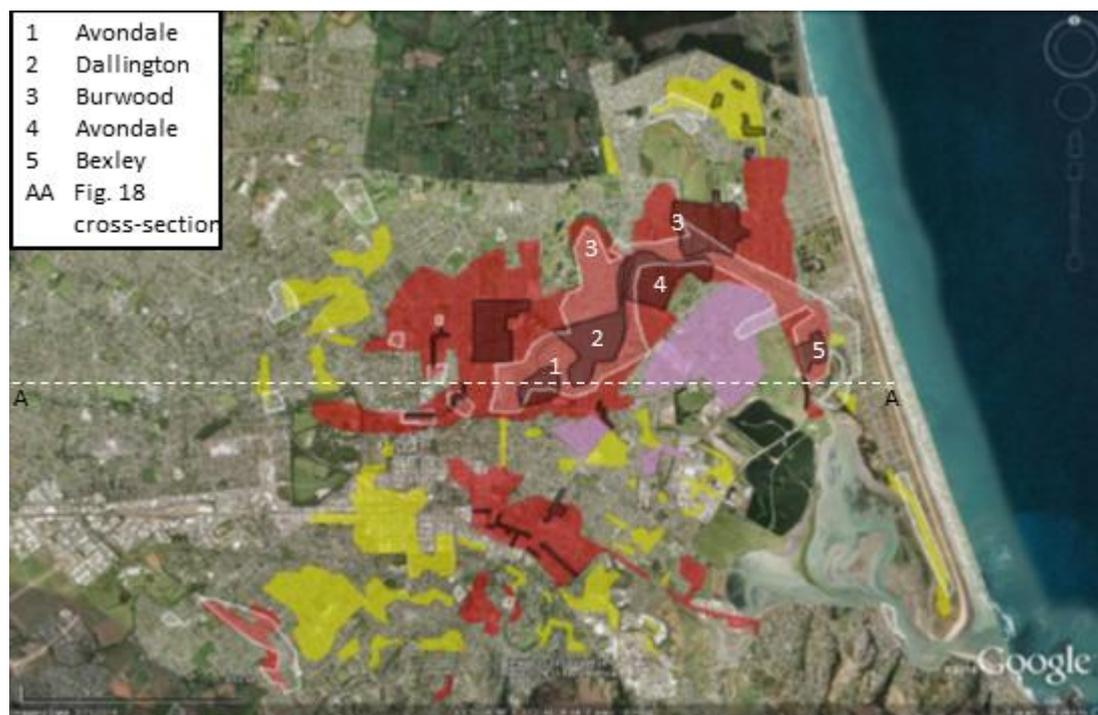
Soil liquefaction repeatedly occurred at some sites during the earthquakes producing strong ground shaking in Christchurch, and in particular during the 4 September 2010, 22 February 2011, and the M_w 5.5 and M_w 6.0 13 June 2011 earthquakes. Figure 5 comparatively shows liquefied areas of Christchurch in these three events, as documented by field investigations. The repeated liquefaction was often quite severe and many residents reported that in some cases the severity increased in subsequent events.

Figure 5: Preliminary liquefaction maps documenting areas of observed liquefaction in the 4 September 2010 (white contours), 22 February 2011 (red, yellow, magenta areas), and 13 June 2011 (black contours) earthquakes [12].

The distribution of liquefied areas shown in Figure 5 reflects the combined effects of two important factors for liquefaction triggering: the soil resistance to liquefaction (a measure for the capacity of soils to sustain cyclic loading) and the severity of ground motions (measure for the seismic load or demand) produced by the two quakes. The suburbs most severely affected by liquefaction in Christchurch were along the Avon River to the east and northeast of CBD (Avonside, Dallington, Avondale, Burwood and Bexley). The soils in these suburbs are predominantly loose fluvial deposits of liquefiable clean fine sands and sands with non-plastic silts. The top 5-6 m are in a very loose state, with a CPT cone resistance, q_c , of about 2-4 MPa. The resistance typically increases to 7-12 MPa at depths between 6 and 10 m, however lower resistances are often encountered in areas close to wetlands. The more extensive liquefaction observed in these areas during the February 2011 earthquake is consistent with the fact that the seismic demand specific to liquefaction was about 1.5 to 2.0 times higher during the February event as compared to the September 2010 earthquake. Similarly, at the southwest end of the city in Hoon Hay and Halswell, more extensive liquefaction occurred during the 2010 Darfield earthquake.

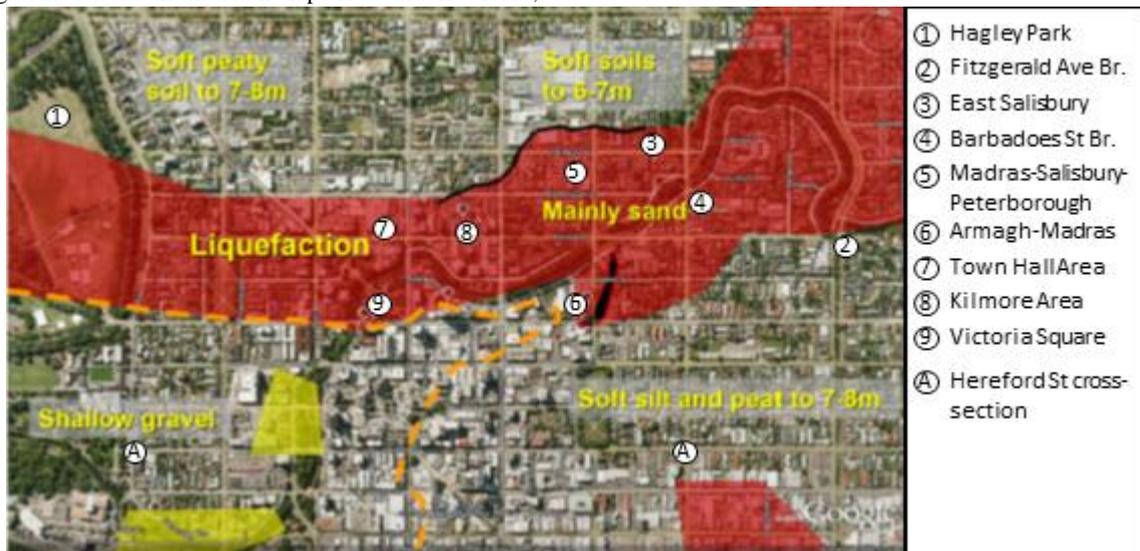
Figure 7 shows the resulting liquefaction documentation map for the CBD. The principal zone of liquefaction stretches west to east through the CBD, from Hagley Park in the west, along the Avon River to the northeast boundary of the CBD at the Fitzgerald Avenue Bridge. This zone is of particular interest because many high-rise buildings on shallow foundations and deep foundations were affected by the liquefaction in different ways. Note that this zone consists mostly of sandy soils and largely coincides with the path of the Avon River and network of old streams shown in 1850's survey maps [12]. The performance of the surficial soils in the 22 February 2011 earthquake is also significant because liquefaction-induced

The northern extent of the zone, which is shown by the thick solid line in Figure 7, is a clearly defined geomorphic feature running east-west that was delineated by a slight change in ground elevation of about 1 m to 1.5 m over approximately 2 m to 10 m wide zone. After the 22 February event, it was further characterized by ground fissuring or distortion associated with localized spreading, as well as gentle slumping of the ground surface on the down slope side. Ground cracks,

fissures and a distorted pavement surface marked this feature, which runs continuously through properties and affected a number of buildings causing cracks in both the foundations and superstructures. Liquefaction and associated ground deformation were pronounced and extensive on the down slope side between the identified geomorphic feature and the Avon River, but noticeably absent on the slightly higher elevation to the north (upslope side away from the river). This feature is thought to delineate the extent of a geologically recent river meander loop characterized by deposition of loose sand deposits under low velocity conditions. A similar geomorphic feature was observed delineating the boundary between liquefaction damage and unaffected ground within a current meander loop of the river to the east of this area (Oxford Terrace between Barbadoes Street and Fitzgerald Avenue).

Figure 7: Preliminary CBD liquefaction map for the 22 February earthquake [10]; predominant soils in the top part of the deposits are also indicated [12].

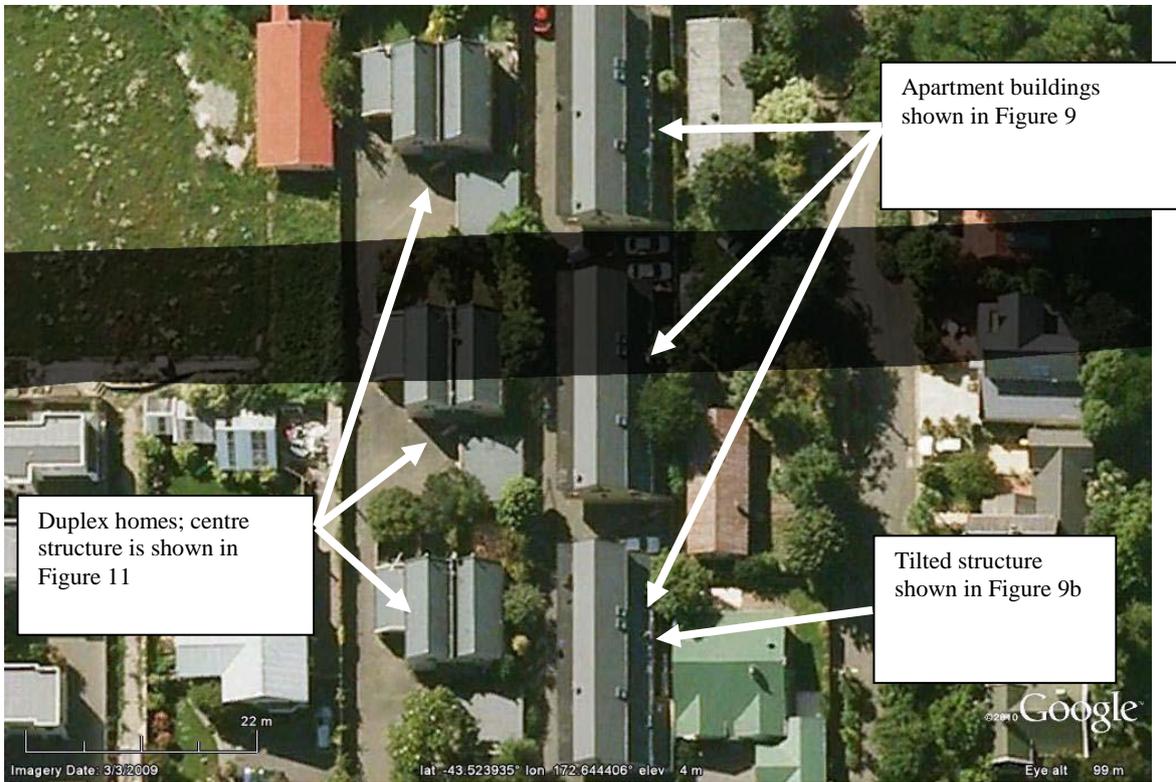
Figure 10: Location of geomorphic feature in area of apartment and duplex complexes north of Salisbury Street in CBD [7].

building located on the higher level to the north suffering no damage, and the buildings located below the crest suffering progressively higher amounts of damage. This geomorphic feature, which is expressed here by a significant change in grade of the pavement between the northern and middle buildings, is shown in Figure 10. The northern building that sits on the higher ground showed no evidence of cracking and distortion of the pavement surface. Conversely, large sediment ejecta were found along the perimeter of the southern building indicating severe liquefaction in its foundation soils (Figure 9b). Liquefaction features were also observed near the middle building, but the resulting distress of this building was significantly less than that of the southern building. The southern building had a shortened end wall with a column at its southwest corner, which appeared to produce additional settlement at the location of the column's concentrated load. It suffered differential settlement of about 40 cm and over 3 degrees of tilt towards the west-southwest, which is visible in Figure 9a. This building was uneconomical to repair and was demolished after the 22 February 2011 earthquake. Adjacent to these buildings is another complex of three identical but structurally different buildings from the former set. Their locations relative to the abovementioned geomorphic feature is identical, but these buildings are two-storey duplexes. Figure 11a shows the middle building with clear evidence of pavement distortion, cracking and settlement of the surrounding ground. The settlement of the building was likely not significant, but the ground settled about 20 cm exposing the top of the foundation at the southwest corner (Figure 11b).

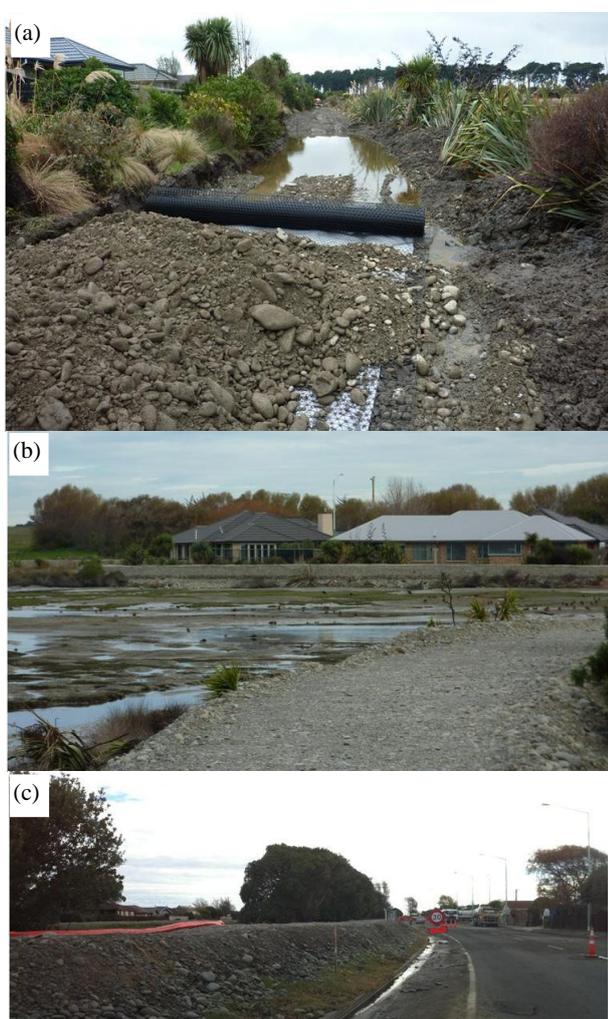
Emergency stop banks were initially constructed due to the expected spring tides in April 2011. These were built up to 1.8 m above mean sea level (MSL), with 11 km of stop banks built over four days along the Avon River. Silty gravel was used for the construction material, as it was readily available and reasonably impermeable. Lateral spreading cracks were filled prior to stop bank construction, but otherwise there were no improvements to the foundation material. An example of the stop bank construction along the Bexley Wetland is shown in *Figure 25a*, with a geogrid used under stop banks if the foundation material was weak. Large settlements in this area meant that many houses that were approximately a metre above the water level now sit below the crest of the stop banks (*Figure 25b*). Overall this emergency system performed well during the spring tides.

Figure 25: (a) Fill material used for construction and geogrid/liner for temporary stop banks; (b) position of residences below temporary stop banks in Bexley wetland; and (c) stop bank construction along New Brighton Rd.

areas with limited space, reinforced earth and diamond block walls were used. An example of stop bank construction in *Figure 25c* shows the height of the stop banks relative to the roadway. Flood levels along the Avon River are approximately 3 m above MSL, meaning that stop banks with crests 1.4 m above the current ground levels would be required in places. Hence, seawalls and treatment of the foundation soils may be required to provide adequate flood protection in the medium to long term.

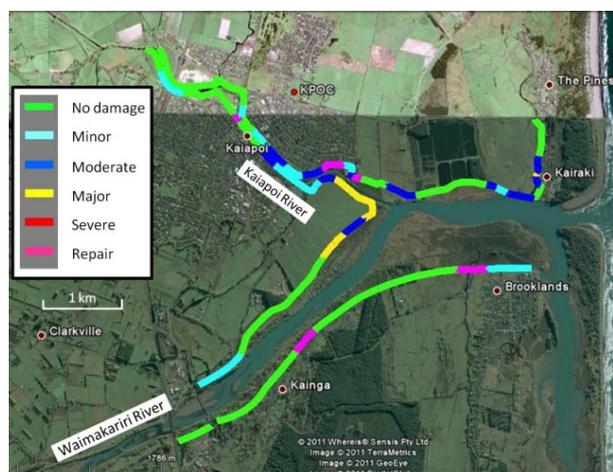
The majority of stop bank damage from the Christchurch earthquake occurred east of State Highway 1 (SH1) as shown in Figure 28. In this figure, damage severity is categorized using the scale given in Table 2. The scale has five grades that range from No Damage to Severe Damage. The damage patterns shown in Figure 28 are very similar to those from the Darfield earthquake, but are in general less severe for the Christchurch earthquake. The principal reason for this is that the ground motion severity is inferred to be less for the Christchurch earthquake than the Darfield earthquake in this

Figure 28: Observed damage to stop banks following the Christchurch earthquake [20], [19]

To examine the relationship between the severity of the induced damage to the stop banks and the liquefaction response of the foundation soil, a stretch of stop banks along the Kaiapoi River was examined in more depth. As shown in Figure 28, these stop banks sustained damage ranging from No Damage to Severe Damage (Table 2). Following the Darfield earthquake, the New Zealand Earthquake Commission (EQC) contracted a local firm to perform a series of cone penetration tests (CPT), among other in-situ tests, throughout North and South Kaiapoi [19].

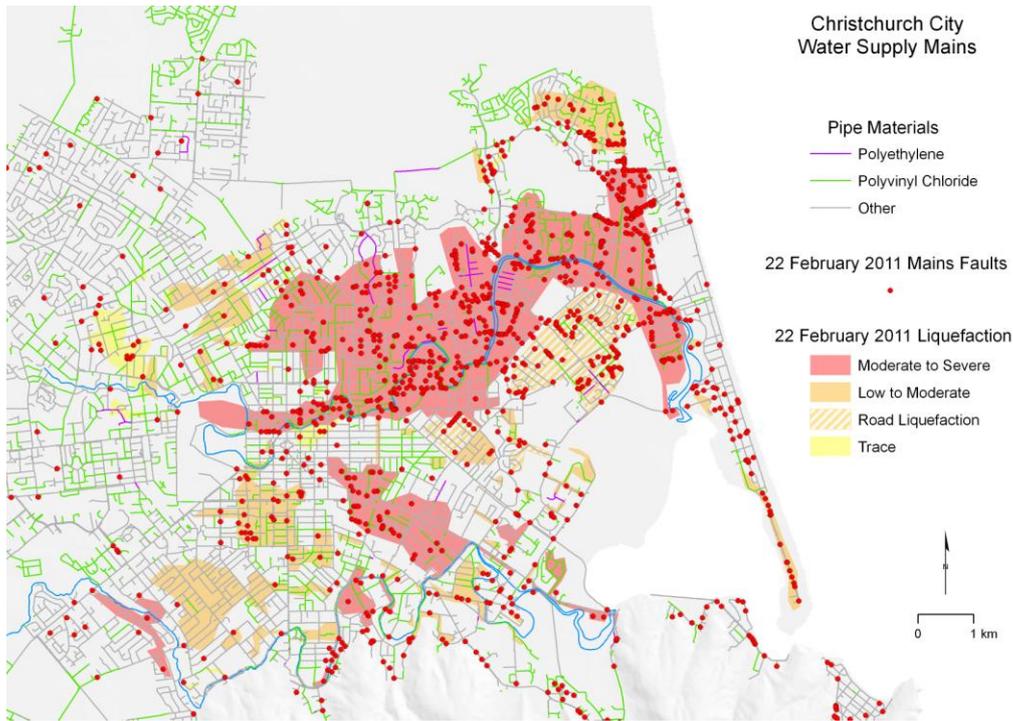
The potable water system is a system of relatively shallow pipe network (mostly in the top 60 cm of the ground). It is a pressurized system composed of mains and sub-mains. Figure 30 shows a summary of the water mains network in Christchurch indicating pipe materials (solid lines) and the location of breaks (faults; red solid symbols) caused by the 22 February earthquake. Superimposed in this figure is the liquefaction map (shown in Figure 4) indicating the areas affected with different severity of liquefaction. It is apparent in this figure that most of the breaks were located in the area affected by liquefaction. A more rigorous preliminary analysis indicates that about 4.6 % of the pipes (pipe segments) were damaged, or about 78 km out of 1676 km total pipe length. About 80% of the damaged pipes were in areas that manifested either moderate-to-severe or low-to-moderate liquefaction. Similar observations and preliminary findings were obtained for the sub-mains system which is dominated by polyethylene (PE) pipes. Despite the relatively large number of breaks, the potable water supply was quickly restored within several days of the earthquake.

Figure 30: Water mains pipe network and location of breaks (faults) caused by the 22 February 2011 earthquake; coloured lines indicate pipe materials; coloured areas indicate liquefaction severity as defined and mapped in Figure 4.

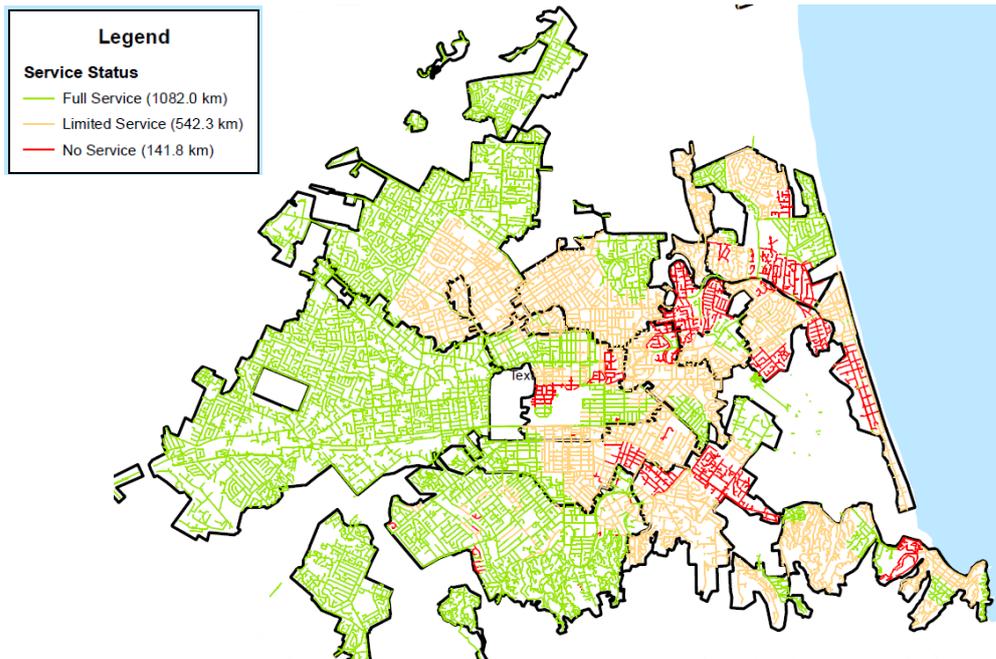
the 1766 km long waste water network, 142 km (8%) were out of service; and 542 km (31%) with limited service on 16 March 2011 (i.e. three weeks after the February earthquake), as shown in Figure 31. A significant part of the network was still out of service even three months after the earthquake, and it is estimated that it will take two to three years to fully recover the system.

Figure 31: Waste water service status on 16 March 2011. (M. Christison, pers. comm.)
