FULL-SCALE FIRE TESTS OF POST-TENSIONED TIMBER BEAMS

ABSTRACT: This paper describes a series of full-scale furnace tests on loaded post tensioned LVL beams. Each beam was designed to exhibit a specific failure mechanism when exposed to the standard ISO834 fire. In addition to the beams a number of steel anchorage protection schemes were also investigated. These included wrapping the ends in kaowool, using intumescent paint, covering the anchorage with fire rated plasterboard and covering the anchorage with timber (LVL). The results of the full-scale tests cover temperature distributions through the timber members during the tests, the temperatures reached within the cavity and those of the tendons suspended within the cavity, the relaxation of the tendons during the test, the failure mechanisms experienced, and a summary of the anchorage protection details and their effectiveness. Recommendations for the design of both post-tensioned timber beams and associated anchorages are also provided.

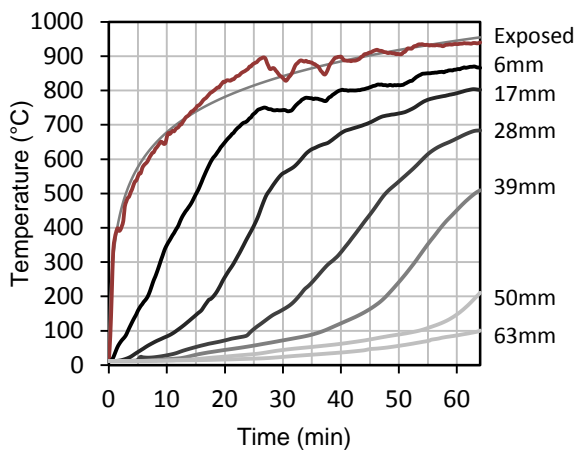
Figure 11: LVL temperature distribution in web of Test 1. Temperatures are presented for various depths below the original LVL surface.

Beneath the surface, the temperatures slowly approached 100 °C slowly and rapidly increased in temperature after 100°C was reached, most likely due to moisture migration and evaporation in the timber.

The bottom flanges heated slightly more quickly than the webs. Two possible explanations for this are that the flange partially shields the web from some of the furnace and therefore receives more radiation, or that the width of the beam became small enough that the two-dimensional heat transfer served to increase the temperature more quickly.

The temperature of the inside face of the LVL did not rise beyond 100°C whilst the beams were still intact. The temperature distribution of the web at various times for the beam in Test 1 is presented in Figure 11. This was typical for all tests.

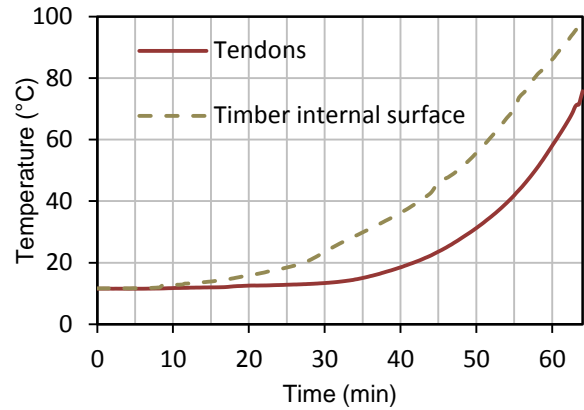
Figure 12: Average temperature of the post-tensioning tendon and the internal surface of the timber cavity of Test 1. Internal surface profile presented as recorded in the lower corner of the cavity.

As the timber sections charred, the inside face of the section became warmer. The tendon within the cavity also increased in temperature. In none of the experiments did the tendons nor the interior internal timber surfaces become hotter than 100°C before failure. In Test 1 the timber surfaces reached 100°C at 64 minutes just before failure whereas the tendon had only reached 75°C. After 45 minutes the internal timber surface was approximately 25-30°C hotter than the tendon. However the tendon temperature may have partially caught up with the timber temperature if the test progressed longer than 64 minutes. The temperature of the internal surface and the tendon are presented in Figure 12.

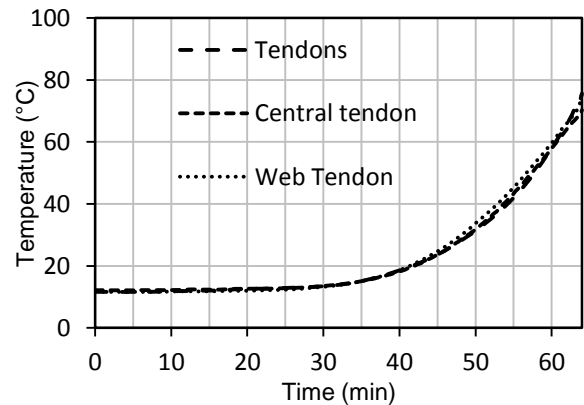
Figure 13: Temperature profiles for different tendon positions.

The position of the tendon within the cavity in Test 1 showed little effect on its temperature. The positions, near the bottom flange, near the web and near the centre of the cavity, showed a maximum temperature difference of 2 °C. The temperature profiles for the tendon at various positions are presented in Figure 13.

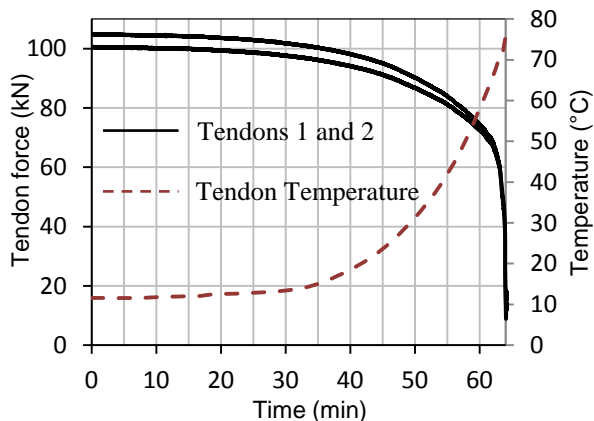
Figure 14: Tendon post-tensioning force and tendon temperature during Test 1.

During Test 1 the tendons had lost approximately 25% of their initial applied stress at 60 minutes. At this time the tendon temperature was approximately 58°C. Before 30 minutes of fire exposure both the temperature and

post-tensioning force were only negligibly affected by the fire. Figure 14 shows the tendon force and temperature of the tendons within the beam in Test 1.

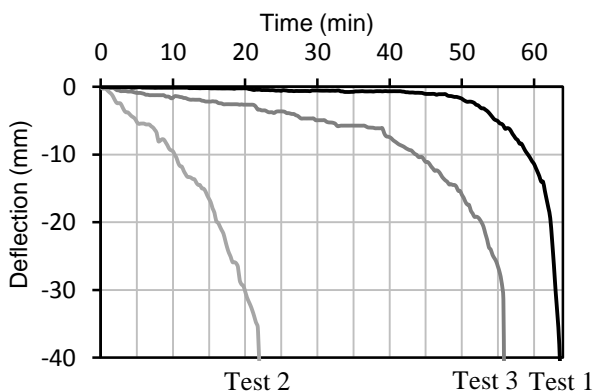
Figure 15: Vertical deflections of the main test beams.

During Test 1 the deflections remained in the order of 0.5 mm-1 mm for the first 45 minutes. Beyond this the deflections started to increase steadily until approximately 64 minutes, where a runaway deflection occurred. The deflections measured during each test are presented in Figure 15.

During Test 2 the deflections increased at an approximately constant rate for 15 minutes, and then increased slightly until failure at 22 minutes. The mechanism of failure was different to what was predicted and occurred earlier than expected. The top flange suddenly disconnected from the rest of the beam. The deflection profile reflects this with rapidly increasing deflections early in the test.

The deflection profile during Test 3 was similar to Test 1. However, due to the beam being a smaller size, deflections were greater. The deflections increased approximately linearly for the first 40 minutes of the test. The rate of deflection then increased over the last 16 minutes of the test. At 56 minutes and approximately 30 mm of deflection the beam failed.

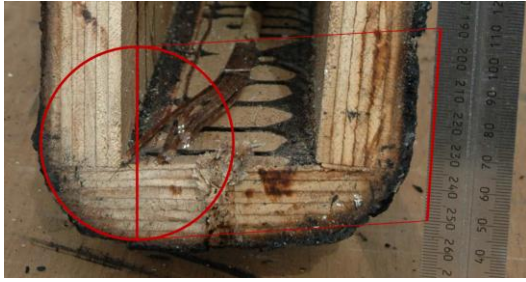
Figure 16: Corner rounding radius fitting

The corner rounding was also measured, this however, was difficult to measure because it is not completely circular and its radius is open to interpretation, based on where measurements are taken. It was more accurate to use digital photography to fit circles to the charred corner profile. An example of the circles fit to the corner profile is shown in Figure 16.

The char rates shown in Table 4 are to the surface of the unburnt timber; however the timber below this layer is still substantially elevated. It was found that with the design methodology developed from these tests [11] the best correlation between predictions and results required the inclusion of an additional 7 mm zero strength layer beneath the char layer to account for the loss of strength and stiffness of the heat affected material. This 7 mm zero strength layer is suggested in Eurocode 5 part 2 [12] as one method to include temperature affected timber.

- A minimum char rate of 0.72 mm/min should be used for New Zealand LVL. However, it is important to include an additional 7mm zero strength layer during design.
- During design of post-tensioned timber members it is important to consider the following failure mechanisms
 - o Longitudinal shear failure in the webs near the centroid of the cross-section.
 - o Longitudinal shear failure at any charred corner of the member.
 - o Combined bending and compression failure at mid-span.
 - o Combined bending and compression failure at the end of the beam due to the moments and axial loads induced by the post-tensioning.
