**"THE BALLANTYNES DEPARTMENT STORE
FIRE DISASTER"**

CHRISTCHURCH

18 NOVEMBER 1947

D.C. NORTON AND B. GORDON

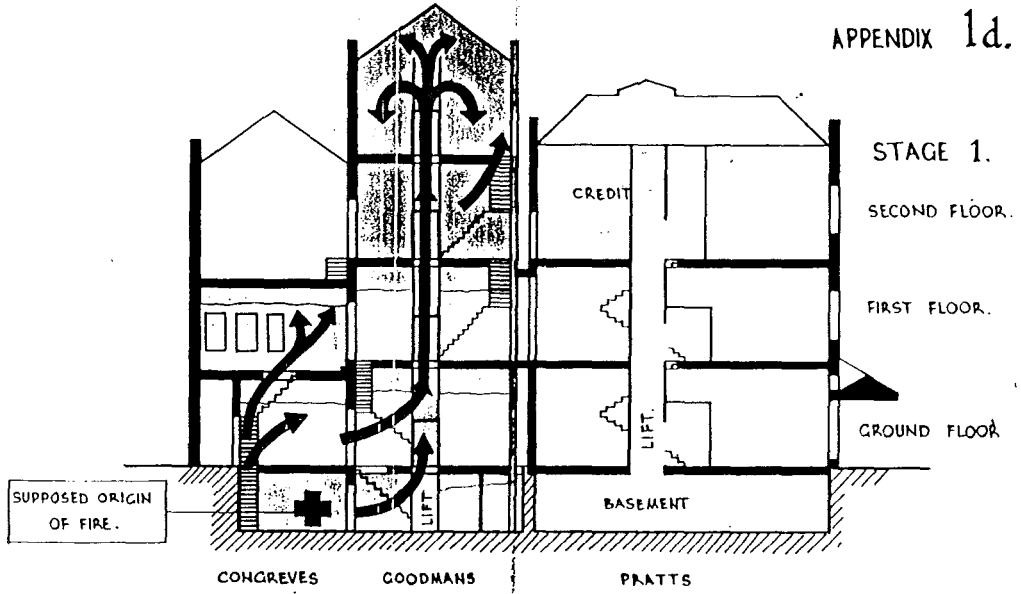
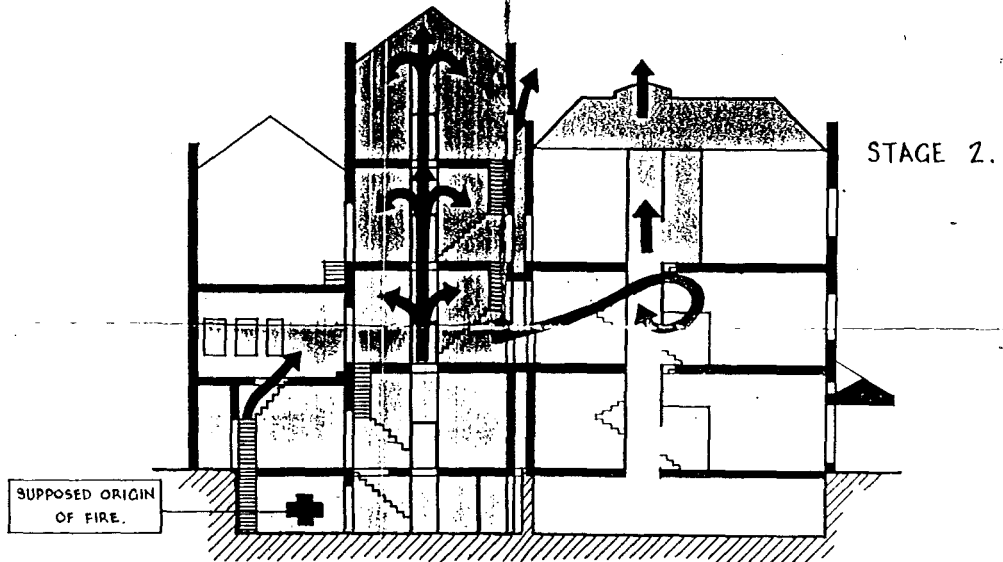
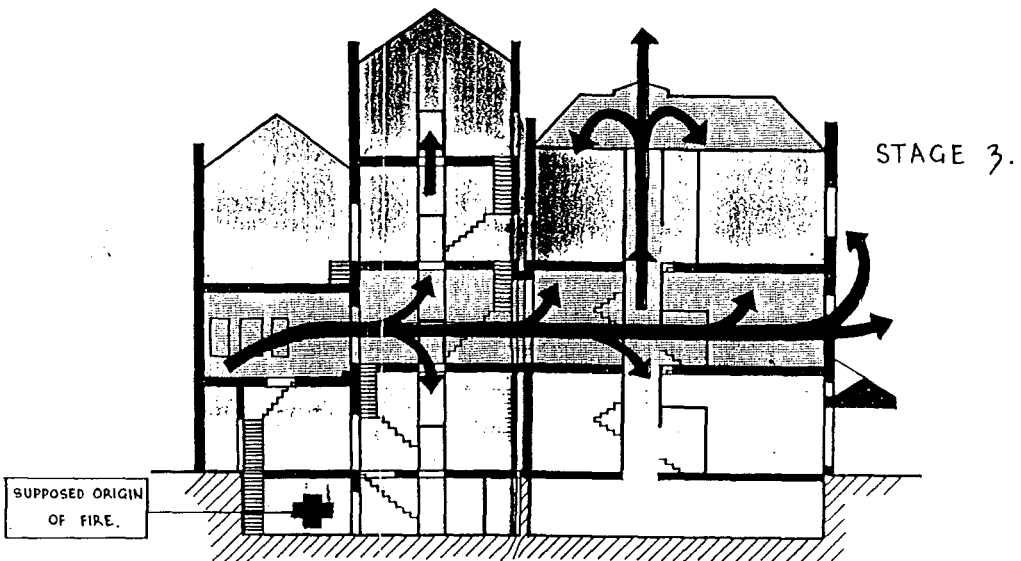
SECTIONS - SOUTH TO NORTH - LOOKING FROM COLOMBO STREET.

ASSUMED SPREAD OF SMOKE AND FIRE.

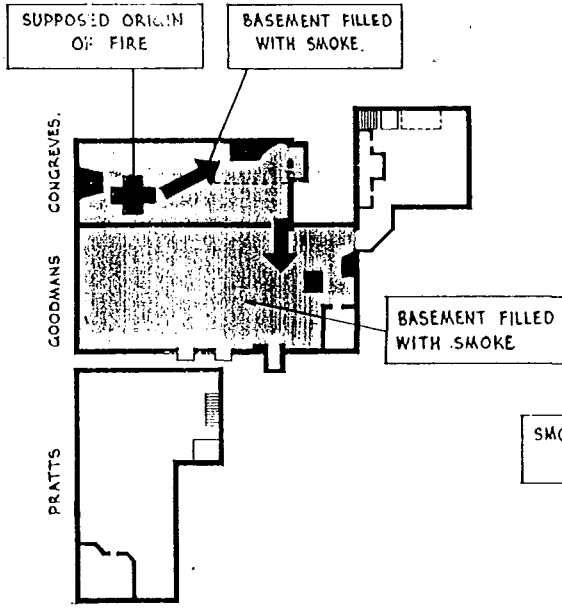
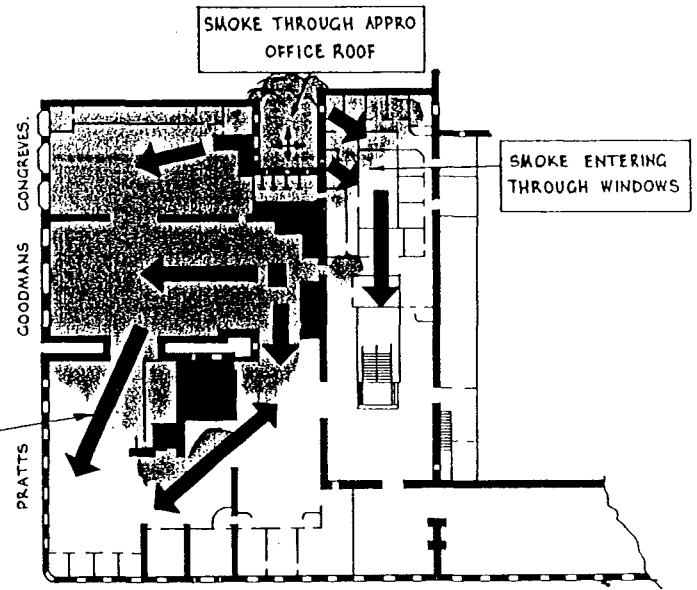
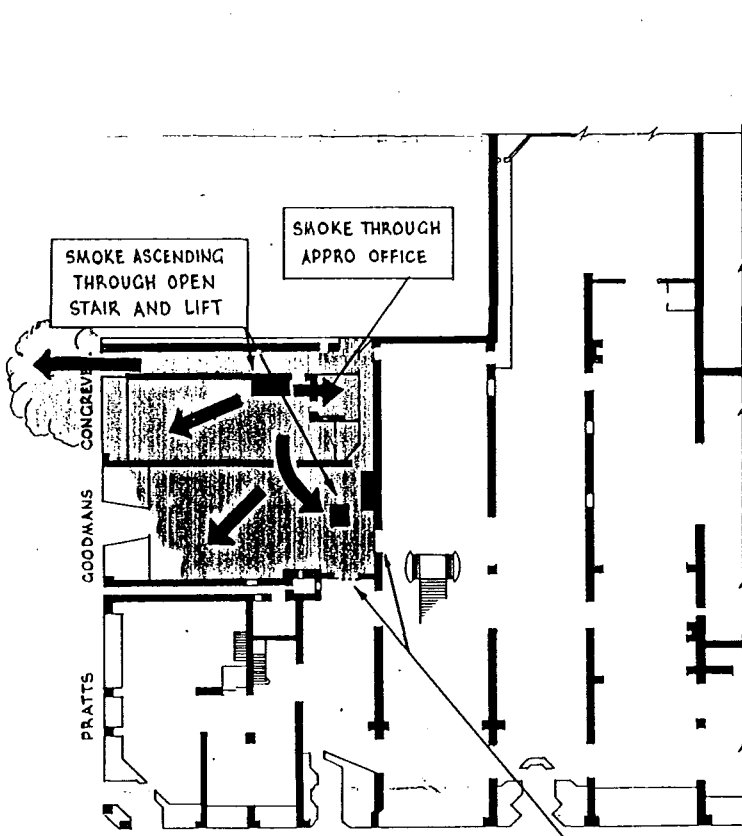
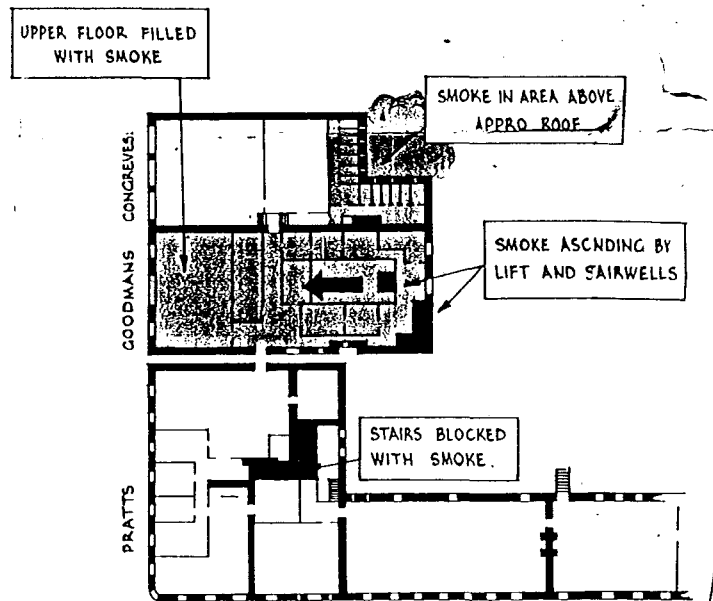
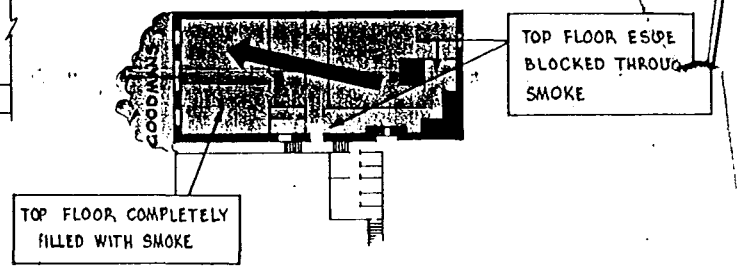
PLANS SHEWING ASSUMED SPREAD OF SMOKE AND FIRE STAGE 2

SMOKE CHECKED BY FIRE DOORS.

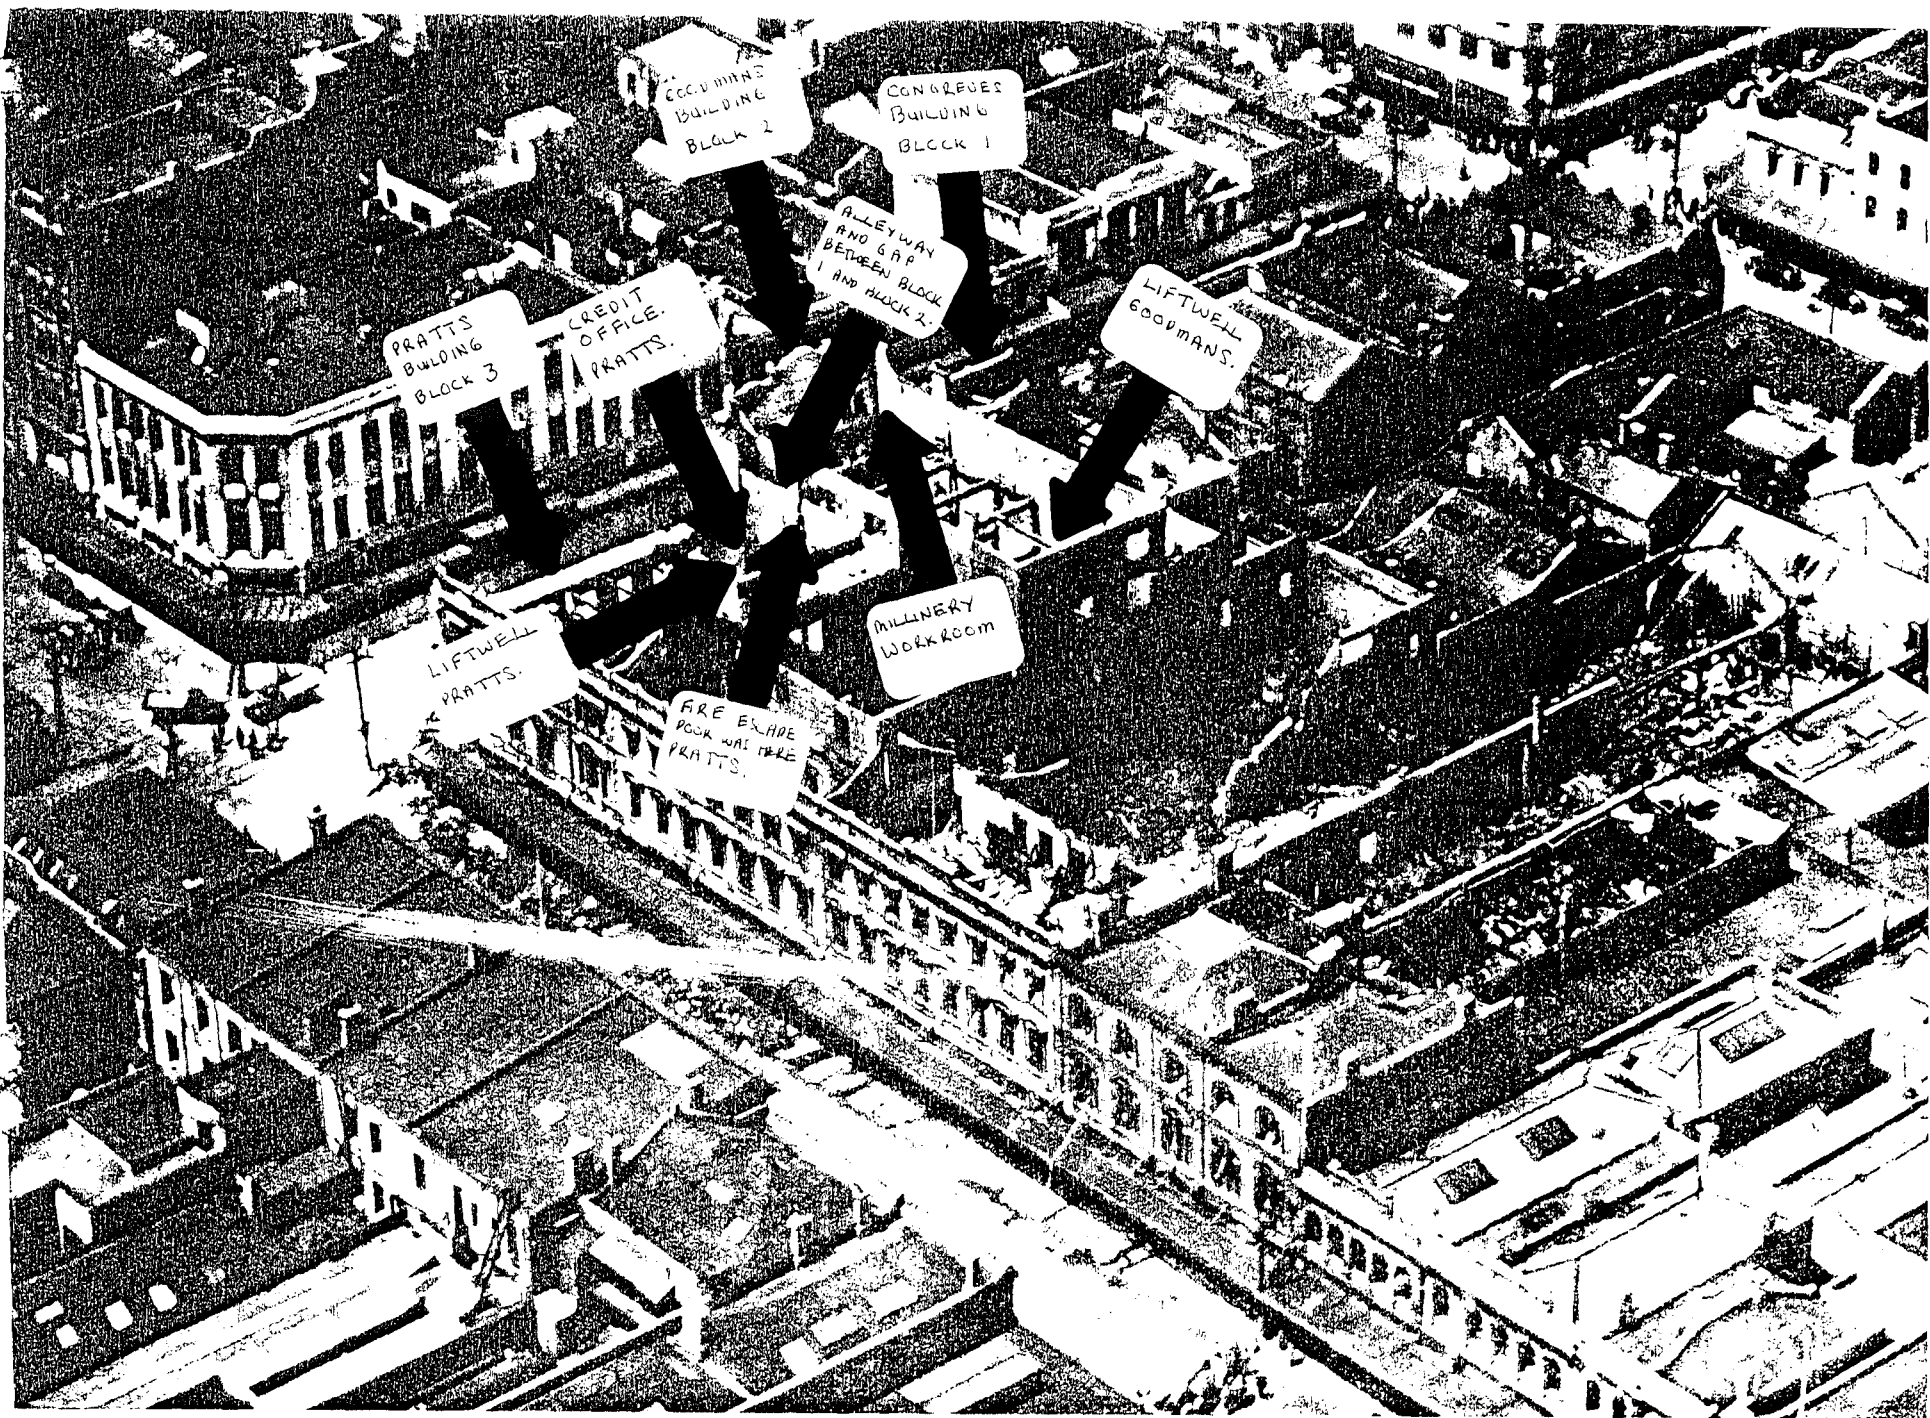
girls leaped to the veranda. LOWER LEFT: the top of a main wall falling into Colombo Street. It was pulled down as a safety-precaution.

LOWER RIGHT: an aerial view on the day after the fire, showing the extent of the destruction in the buildings.
