Geotechnical Aspects of the 2010 Darfield (Canterbury) Earthquake

Misko Cubrinovski¹

ABSTRACT

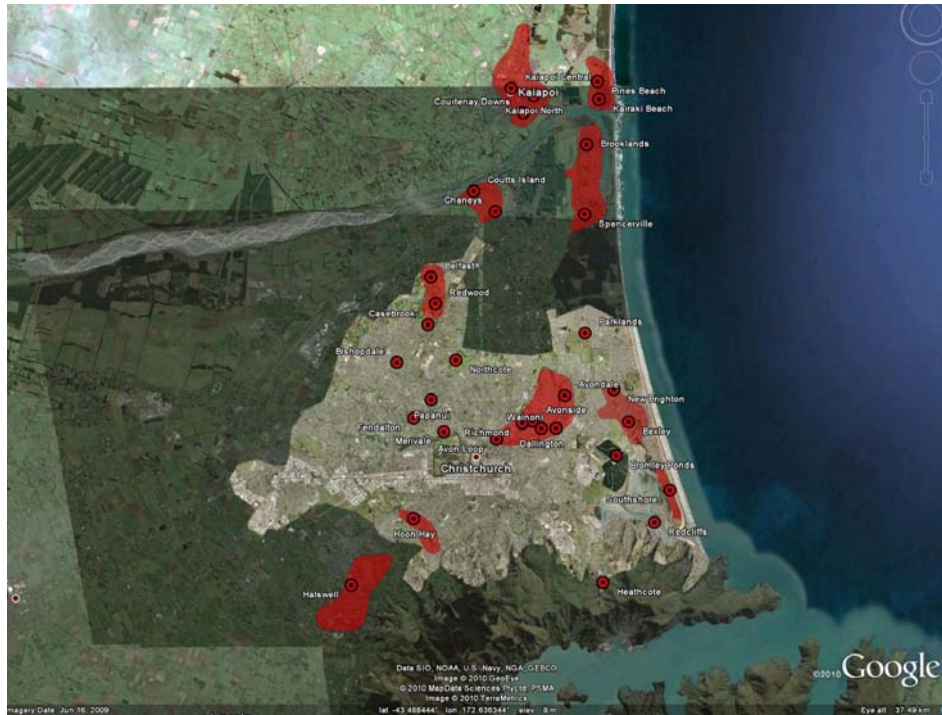
The Darfield earthquake caused widespread liquefaction in the eastern suburbs of Christchurch along the Avon River, particularly in Avonside, Dallington, Burwood and Bexley. Other suburbs, particularly to the east and northeast of CBD, were also affected by liquefaction, but to a lesser extent. Widespread liquefaction also occurred in Halswell, at the southwest end of the city. Pockets of limited or partial liquefaction were observed in various parts of Christchurch, though these were much fewer to the west of CBD. Figure 7 shows areas of observed liquefaction in the urban area of Christchurch based on surface manifestation of liquefaction visible in aerial photographs and initial observations from ground surveying. The areas most severely affected by liquefaction were close to waterways (rivers, streams, swamps). The effects of liquefaction were often localized and changed substantially over a relatively short distance (50-100 m) from very severe to low or no manifestation of liquefaction.

Figure 7. Areas of observed liquefaction (red shaded regions and red points) in Christchurch due to the 2010 Darfield Earthquake (the liquefaction map is based on surface manifestation of liquefaction visible in aerial photographs and compiled evidence from ground surveying)

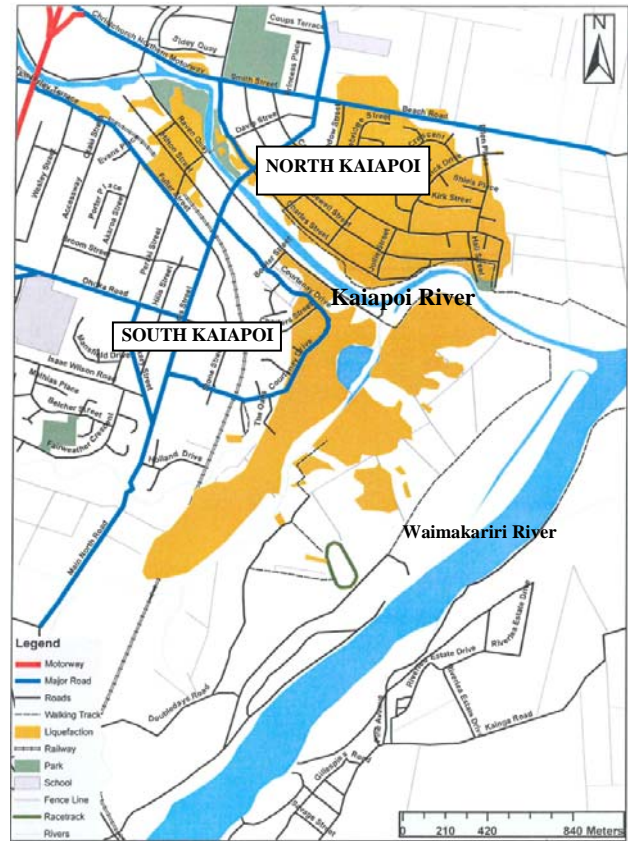
In the Darfield earthquake, widespread liquefaction occurred north of the Kaiapoi River affecting a large number of residential houses in the town of Kaiapoi. The houses in this area are typically single or two-storey brick/stone block masonry or timber structures on spread footings. Figure 12 shows areas of severe and moderate-to-low liquefaction in the town of Kaiapoi observed from ground surveying and aerial photos. The strong motion records shown in Figure 5b were recorded in North Kaiapoi, outside the liquefied area shown in Figure 12.

lifelines. The intensity of liquefaction gradually decreased from severe to moderate-to-mild and no liquefaction when moving away to the north or west from the Beswick St-Cass St-Askeaton Dr block.

Figure 12. Areas of observed liquefaction in the town of Kaiapoi due to the 2010 Darfield Earthquake; the liquefaction map is based on surface manifestation of liquefaction visible on aerial photographs and compiled evidence from ground surveying

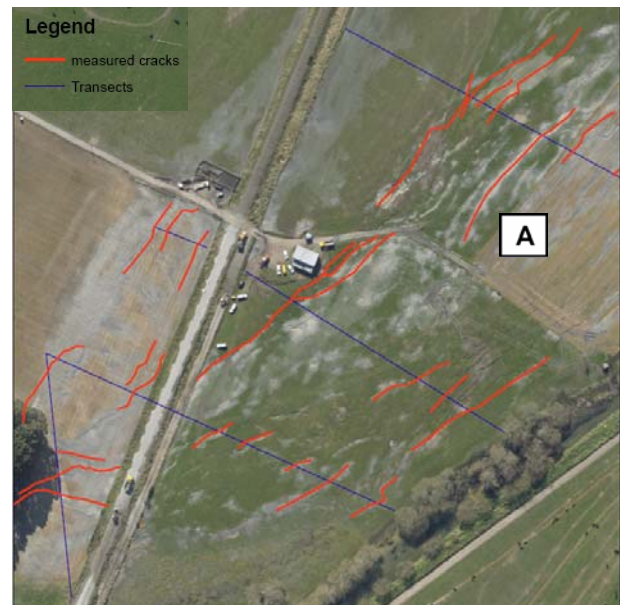
Figure 17. Aerial view of the lateral spread area at position A at South Kaiapoi showing four transects of detailed ground surveys

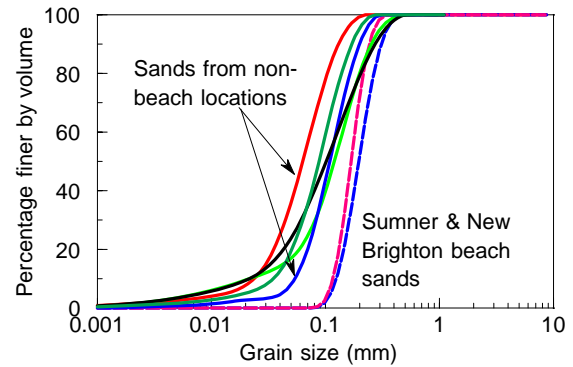
Grain-size distribution curves of ejecta samples taken from Dallington, Porritt Park and South Kaiapoi are shown in Figure 19a. Figure 19b shows grain size distribution of soil samples taken from the SWS screw point (representative of the deepest layer penetrated in a SWS test), indicating that the deeper soils have higher fines content.

(a) Grain-size distribution curves of sand ejecta obtained by laser diffraction analysis (courtesy of Michael Pender)

Figures 19a and 19c. By and large, clean sands and non-plastic silty sands with fines content predominantly between 10 and 30% liquefied during the Darfield earthquake.

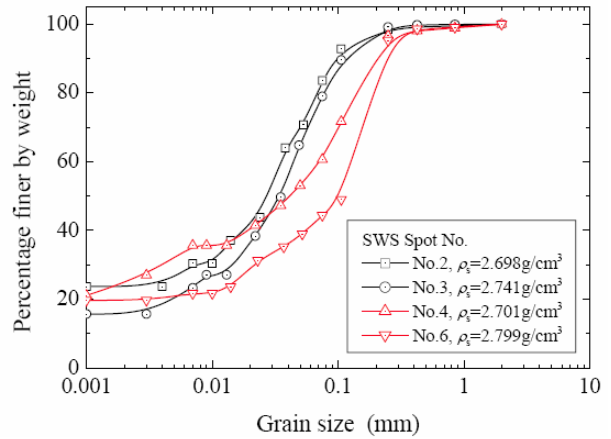
(b) Grain-size distribution curves of soil samples taken from the SWS screw point (deepest tested layer in Swedish Weight Soundings test) obtained by sieve and hydrometer analyses (courtesy of Hirofumi Toyota)

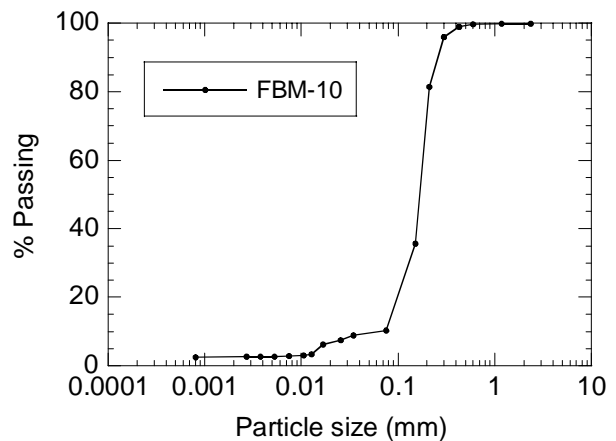
(c) Grain-size distribution curves of soil samples taken from the Fitzgerald Bridge site in Christchurch (Cubrinovski and Rees, 2008)

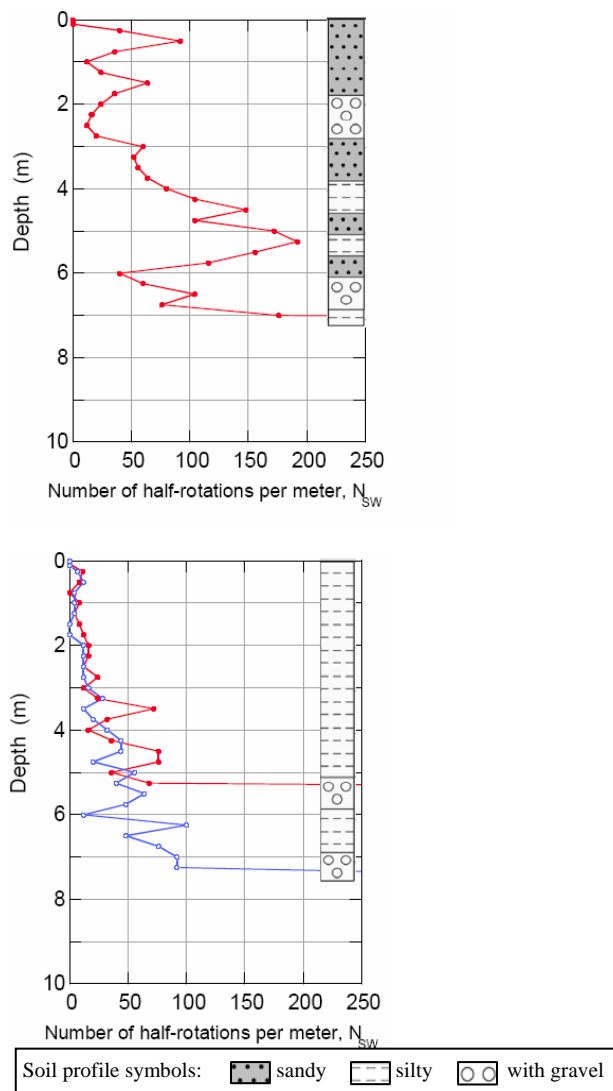
Figure 20 shows the penetration resistance measured in the SWS tests conducted at two locations in Dallington and Avonside, expressed in terms of the number of half-rotations per metre, N_{SW} . The N -value correlations are not presented herein, however, the respective SPT blow count for the penetration resistance shown in Figure 20 is roughly in the range between 5 and 15.

Figure 20. Post-event penetration resistance in Dallington and Avonside measured in SWS tests
