Verification of Raker Shores using New Zealand Timber

T.M. Pettigrew, M. Fragiaco & D.K. Bull

**2006 NZSEE
Conference**

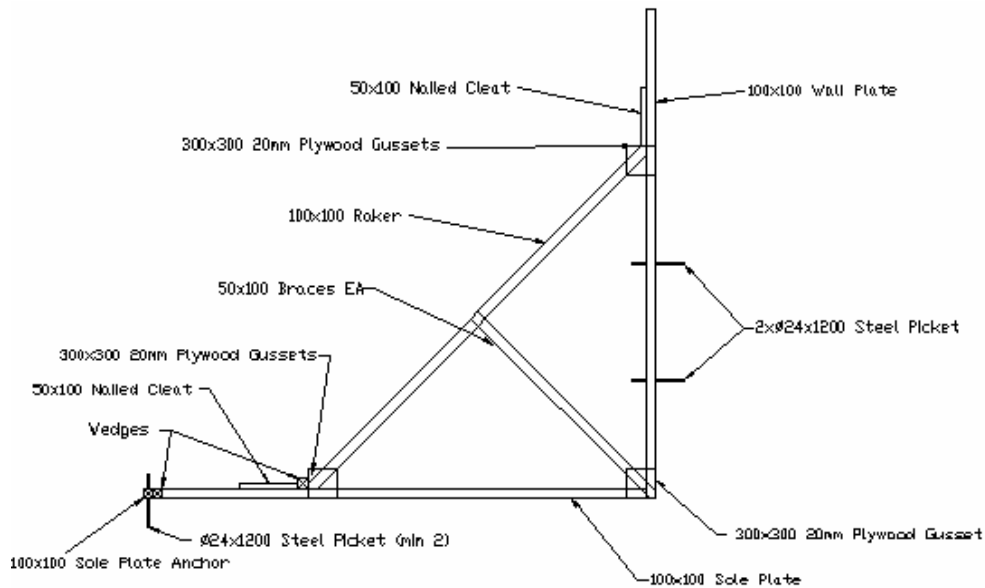
The raker shore is a simple timber truss system which transfers loads from the damaged building to the ground in order to stabilise it. As illustrated in Figure 1 the raker shore comprises three key components: the wall plate, sole plate and raker. Each individual shore also has a mid-point brace, cleats, gussets, spikes, wedges and an anchor plate. These individual shores are usually erected in pairs and joined by lateral braces (Fig. 2). The shores can be braced in a variety of ways, provided they resist lateral flexural buckling at the midpoint of the raker and any lateral forces. The capacity of an individual raker shore is in the range of 2400 lbs; or 10.7kN (Module 2a, undated).

Figure 1 Elevation of raker shore verified

Figures 1 and 2 show the shore used in analysis and testing.

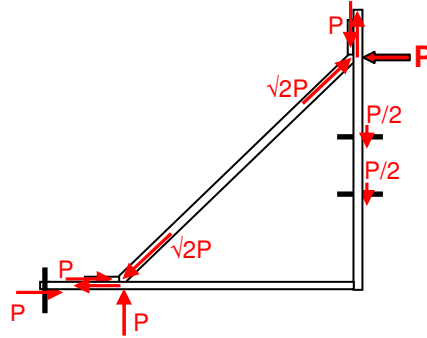
Figure 3 Load paths through the shore

Two key assumptions were made when analysing the loads through the shore. Firstly, that the entire load in the raker parallel to the wall plate or sole plate was transferred to the respective members through the nailed cleat. Friction was ignored as it was deemed insignificant and is unreliable in terms of its effects. The second assumption is that the spikes in the sole plate will not carry load. Although not shown in the following figures, spikes are often put into the ground through the sole plate as well as the anchor plate. It was assumed that the horizontal load applied from the cleats would be transferred to the anchor plate, and not to any spikes put in the sole plate. Each individual shore is designed to resist approximately 10kN; this is the horizontal load, P . This corresponds to a design load of 14.14kN in the raker, 10kN in the wall plate, sole plate, and cleats, and 5kN in the wall spikes.

The raker shores described above were first verified against the New Zealand Timber Structures Standard NZS 3603:1993. Some aspects of the shore were not covered clearly by NZ 3603, in which case the Eurocode 5 (CEN 2003) was used. Firstly, the shore was analysed to find the load paths through the shore and the actions in the various elements (Fig. 3).

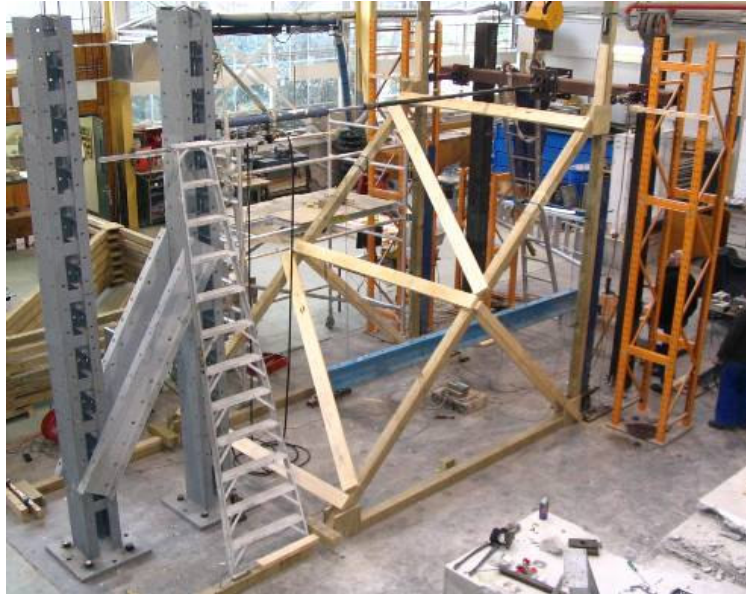
Figure 5 Photo of test setup

Figures 4 and 5 demonstrate the test setup. A rigid test frame was designed to apply two point loads to the individual shores, and a test wall to represent the overturning wall by preventing uplift of the shores. Load cells were placed between the wall plate and test frame to measure the load in the shores, strain gauges were placed on the rakers midway between the brace and the wall plate, and displacement potentiometers were placed at the top of the wall plates, at each cleat, and at the base of the wall plate.

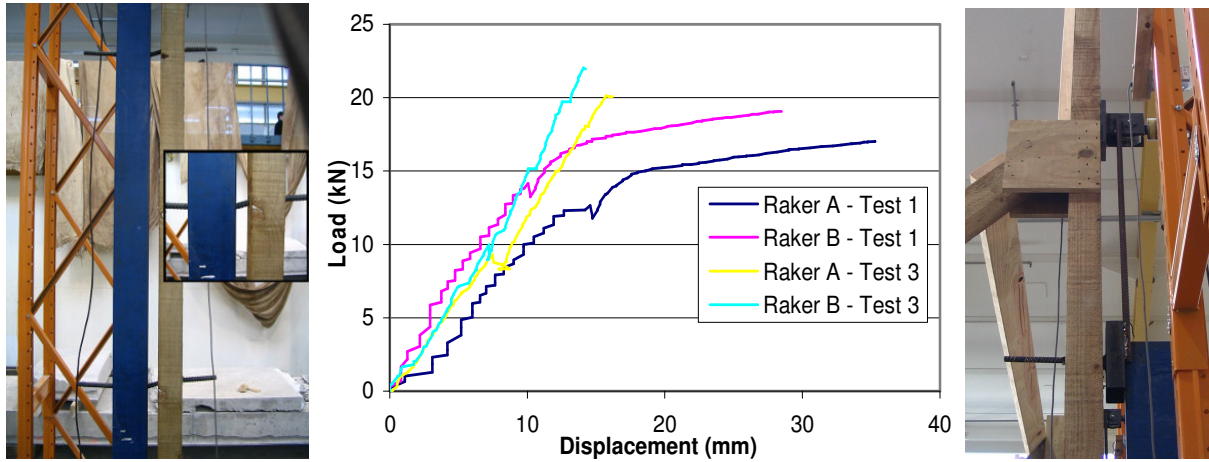
Two tests were done on a typical set of shores used by NZ USAR (Test 1 and Test 3). A unidirectional load was applied to the shores until a load of approximately 20kN was achieved; this gives a satisfactory safety factor of 2. The graph of load-displacement for the two tests is shown in Figure 6. Test 1 shows a steady increase in load until approximately 14kN to 16kN where yielding of the steel spikes occurs, shown by the graph levelling off. This is slightly higher than the predicted plastic yield force of 13.5kN. Strain-hardening of the steel caused the load to slowly increase to a value of 19.1kN and 17.1kN when the test was stopped to minimise damage to the shores. Test 3 shows no evidence of spike yielding. This different behaviour with respect to Test 1 can be justified on the basis of a modification adopted for the setup in Test 3, where the overturning test wall was connected through steel bars to the load cells (Fig. 6). This modification was made in order to keep the distance between the point of application of the load and the hinge of the overturning test wall constant during the whole loading process, so as to better represent a real collapsing wall. Because of such a modification, another load path took place in the test setup, and part of the load was transmitted through the steel bars connecting the overturning wall with the load cells resulting in a decrease of the shear forces in the spike connection, and in a delay of their yielding (Pettigrew 2005).

Figure 6 Test 1 spike connection failure (left), load-disp. graph (centre), setup modification of Test 3 (right)

The results from these tests are very encouraging for NZ USAR. The individual shores were able to carry a load in excess of 20kN which gives a safety factor of 2 for the desired capacity of 10kN. The bending of the spikes is a ductile failure which is highly desirable as it gives warning of failure. The rescue teams will be able to see the spikes bending and evacuate the building before collapse occurs.

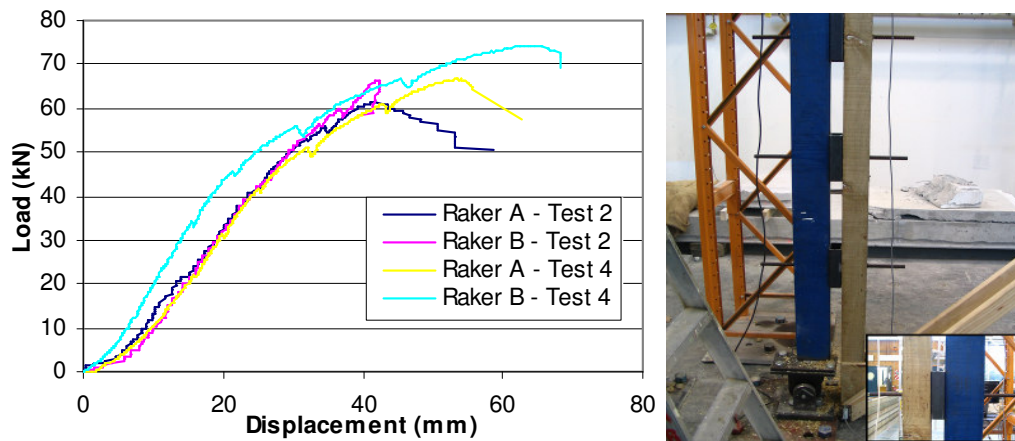
The load-displacement graphs for these tests are displayed in Figure 8. The loads initially increased quite slowly as the residual deformations from the previous tests (Test 1 and Test 3) were recovered. The load then increased relatively linearly until the raker members began buckling where the stiffness decreased. The load reached a maximum value when flexural buckling of the shore was in full development. The load then gradually decreased and displacements increased while the raker continued to buckle until complete rupture of the raker occurred (Fig. 9). The maximum loads in the shores in test 2 were 61.2kN and 66.1kN, and in test 4 they were 66.6kN and 74.2kN. These differences were expected to be due to natural variations in the timber. Buckling of the raker members was a brittle failure which occurred at approximately the midpoint of the brace and end of the member.

Figure 8 Load-displacement graph (left) and strengthened spike connection (right) - Test 2 and 4

The second tests (Test 2 and Test 4) on the first two rakers were performed using strengthened spike connections to identify the next failure mechanism in the hierarchy. The spike connection was strengthened by increasing the number of spikes to five and increasing the yield strength of the spikes to Grade 500, as illustrated in Figure 8. It is acknowledged that the connection would not be set up like this in practice however it was done purely to observe the next failure mechanism.

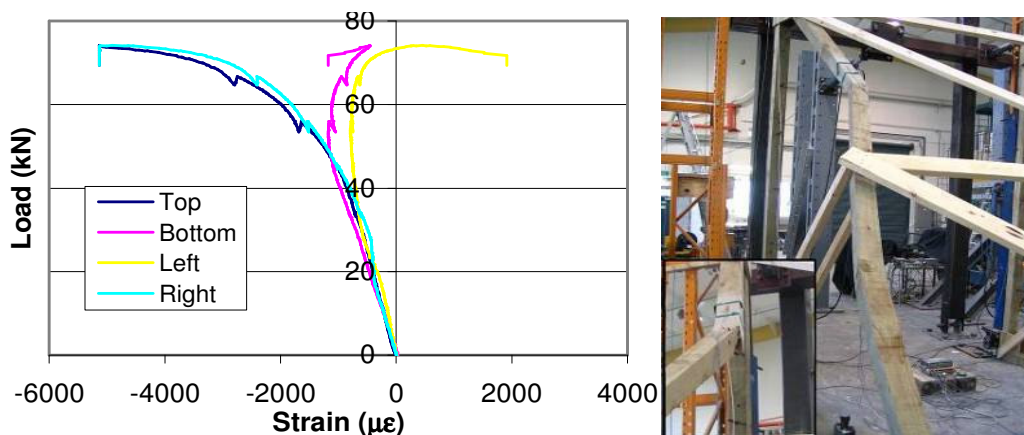
Figure 9 shows the flexural buckling in the raker members. The strain remained relatively linear until the onset of flexural buckling and the strains on opposite faces diverged. The load-strain graph reached an ultimate load then the load dropped off while the strains increased until rupture of the member.

Figure 9 Strains in Raker B (left) and raker shores at collapse (right) - Test 4

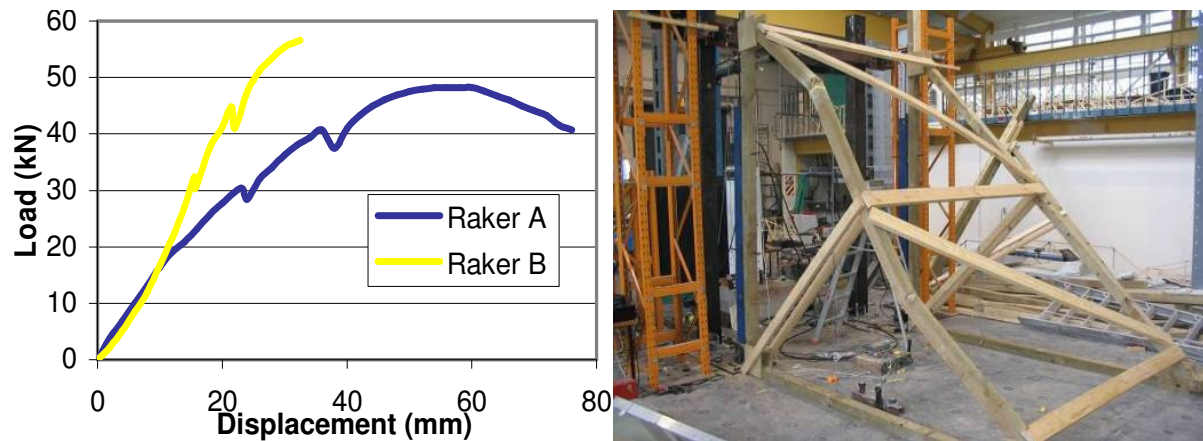
The final test performed was to determine the effect of closing the 50mm gap between the collapsing wall and wall plate using only 2 spikes (Grade 300). This is a possible small improvement NZ USAR may implement to increase the strength of the raker shore. A higher collapse load is expected by closing this gap. The load-displacement plot is illustrated in Figure 10.

Figure 10 Load displacement curve (left) and failure of Test 5 (right)

The key finding in this test was that by closing the gap the spike connection was strengthened sufficiently such that flexural buckling failure occurred, as in Test 2 and Test 4. The maximum loads reached in the shores were 48.6kN and 57.0kN, less than that for the other flexural buckling failures of Test 2 and Test 4, because of the presence of a substantial knot. This result has mixed outcomes for NZ USAR. On one hand the closing of the gap significantly increased the strength, but on the other, a more brittle failure was imposed. To gain a better understanding of the exact performance of the spikes and rakers with a closed gap, more tests should be done to improve the statistical credibility of these results.
