Mehdi Sarrafzadeh, Ken Elwood - University of Auckland

Following the 2010/2011 Canterbury earthquake sequence and the 2017 Kaikoura earthquake, major challenges were faced by engineers and local authorities on the assessment and post-earthquake decisions making processes, for low to moderately damaged reinforced concrete (RC) ductile frame structures (Kim et al., 2017 & Henry et al., 2017). In particular, the need for data and guidelines on the reparability of these structures was a major issue. Largely meeting life-safety performance objectives, an appetite was created for guidance on the effectiveness of simple repairs which would allow re-occupancy of ductile moment-frame structures, following low to moderate earthquake damage. Results from component testing of ductile beam specimens show that under low to moderate damage, deformation capacity and strength are not greatly impacted or are completely recoverable via simple repairs. However, the results for the impact of such repairs on stiffness recovery shows greater variability in effectiveness and are outlined in this study.

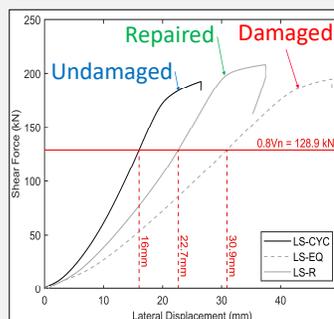
Figure 1: Test configuration and backbone curves for repaired specimens extracted from a damaged RC moment frame in Wellington following the Kaikoura earthquake.

- Specimens were tested in a cantilever beam configuration at a shear span to depth ratio of 2.1 as shown in Figure 1. The estimated peak drift during the Kaikoura earthquake for these specimens was 1.5%.
- Damage consisted of cracking up to 6mm in width and spalling of cover concrete.
- Strength and deformation capacity were not impacted by the earthquake damage.
- One specimen was tested as damaged and one tested following epoxy injection and mortar repair.
- Comparison of initial secant stiffness to yield showed a 25% increase in stiffness following repair (Figure 1), much less effective than slender beams testes by Marder (2018).

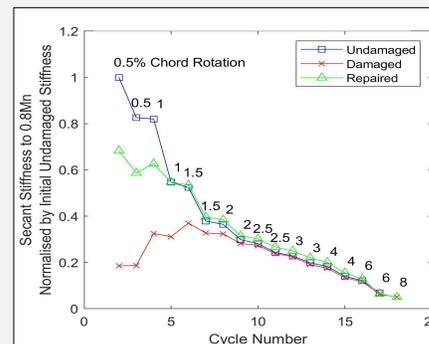
Figure 2: Test configuration for laboratory constructed ductile beam elements and variation in secant stiffness to 0.8Mn for undamaged, damaged and repaired conditions.

- Six specimens were tested in a cantilever configuration at two shear spans of 2.9 and 2.5 respectively. Dynamic earthquake loading with a peak drift of 2.5% was applied to specimens to simulate damage. Damage consisted of cracking up to ~2mm in width in the plastic hinge region.
- Strength and deformation capacity were not impacted by the earthquake damage.
- One beam was tested in an undamaged, damaged and repaired condition at each shear span.
- At both shear spans an increase of 40% in secant stiffness to 80% of nominal strength (calculated in accordance with NZS 3101:2006) was seen, reaching ~70% of undamaged specimen stiffness.
- The testing configuration and an example of the variation in stiffness for the specimens tested at a shear span of 2.9 is shown in Figure 2.
